Bandsaw Safety Program – optimising new and old saws

Project Code
2020-1062

Prepared by
Robert George

Published by
AMPC

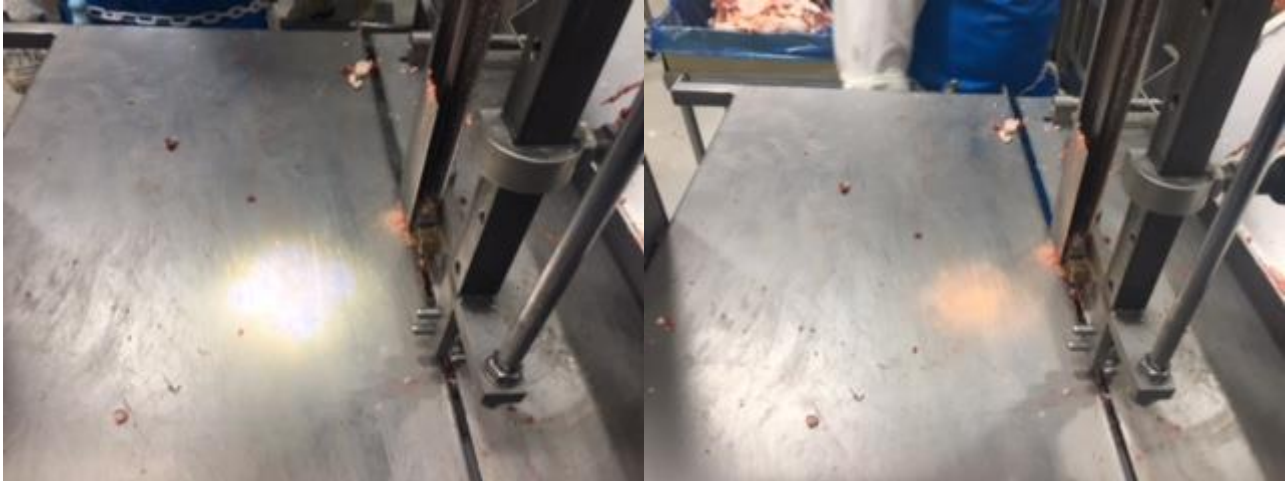
9.1 Appendix 1

2000K light trial.

- The light on a clean table is visible
- By lighting up a section of table away from the work zone distracts the operator from where they should be focusing
- Slight reflectiveness could cause injury

4000K light trial.

- The light is less visible than a 2000K light on the table. (2000K is a more yellow light than the ambient lighting in the room)
- The light was slightly less distracting than the 4000K lighting
- The light was more reflective from the stainless bench when clean creating a potential risk to the operator

Light colour trials with different Kelvin levels

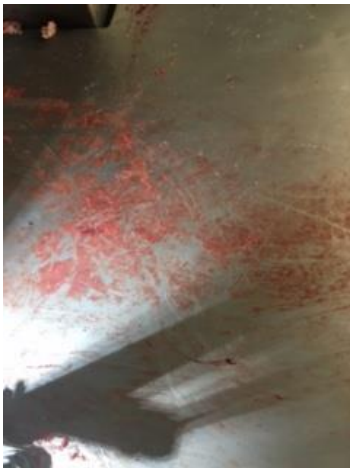
9.2 Appendix 2

Towards the end of a shift, we repeated the Lighting trial to get and understanding what the implications would be from having built up proteins on the bandsaw tables. We found once again that the 2000K light was more visible, but due to the uneven surface and different colours present (light grey, yellow, red and white) it was quite hard to view the light and text would be near impossible. See appendix 2 for photos of this trial

Bandsaw table after production showing the soiling

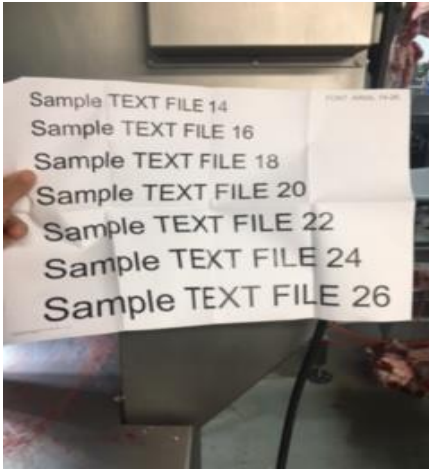
9.3 Appendix 3

We took a sample sheet of paper into the bandsaw and checked text size against readability. It was found that to achieve a readable text it would need a minimum text size of 24mm. See appendix 3 and 4 for a photo of this.

Text size trial to determine visibility

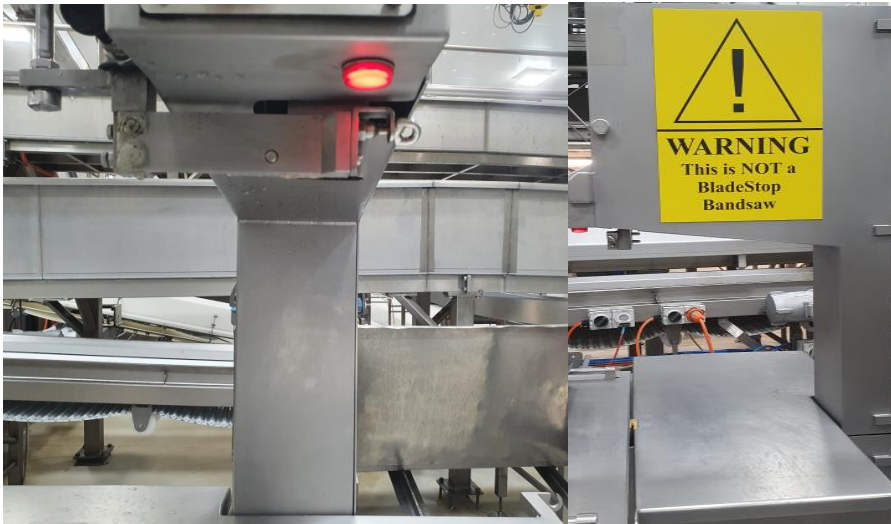
9.4 Appendix 4

Installed lighting and signage to help distinguish which Bandsaw is being operated

- Where alternate bandsaws are being used in the same environment – hard signage is recommended to enhance operator awareness around safety aspects of the saw
- Increase awareness, across industry, that blade stop technology is only an added level of PPE
- Increase awareness, across industry, blade stop technology does not eliminate risk to operators
